**LAND BASED ENVIRONMENTAL MANAGEMENT PLAN
- SUB-PLAN 07**

**North East Business Park
Flood Mitigation Works**

Lot 3 on SP266287, Lot 997 SP309372, Lot 998 SP283244
& Lot 2000 SP309388
Buckley Road, Burpengary East

A Report Prepared for
North Harbour Holdings Pty Ltd

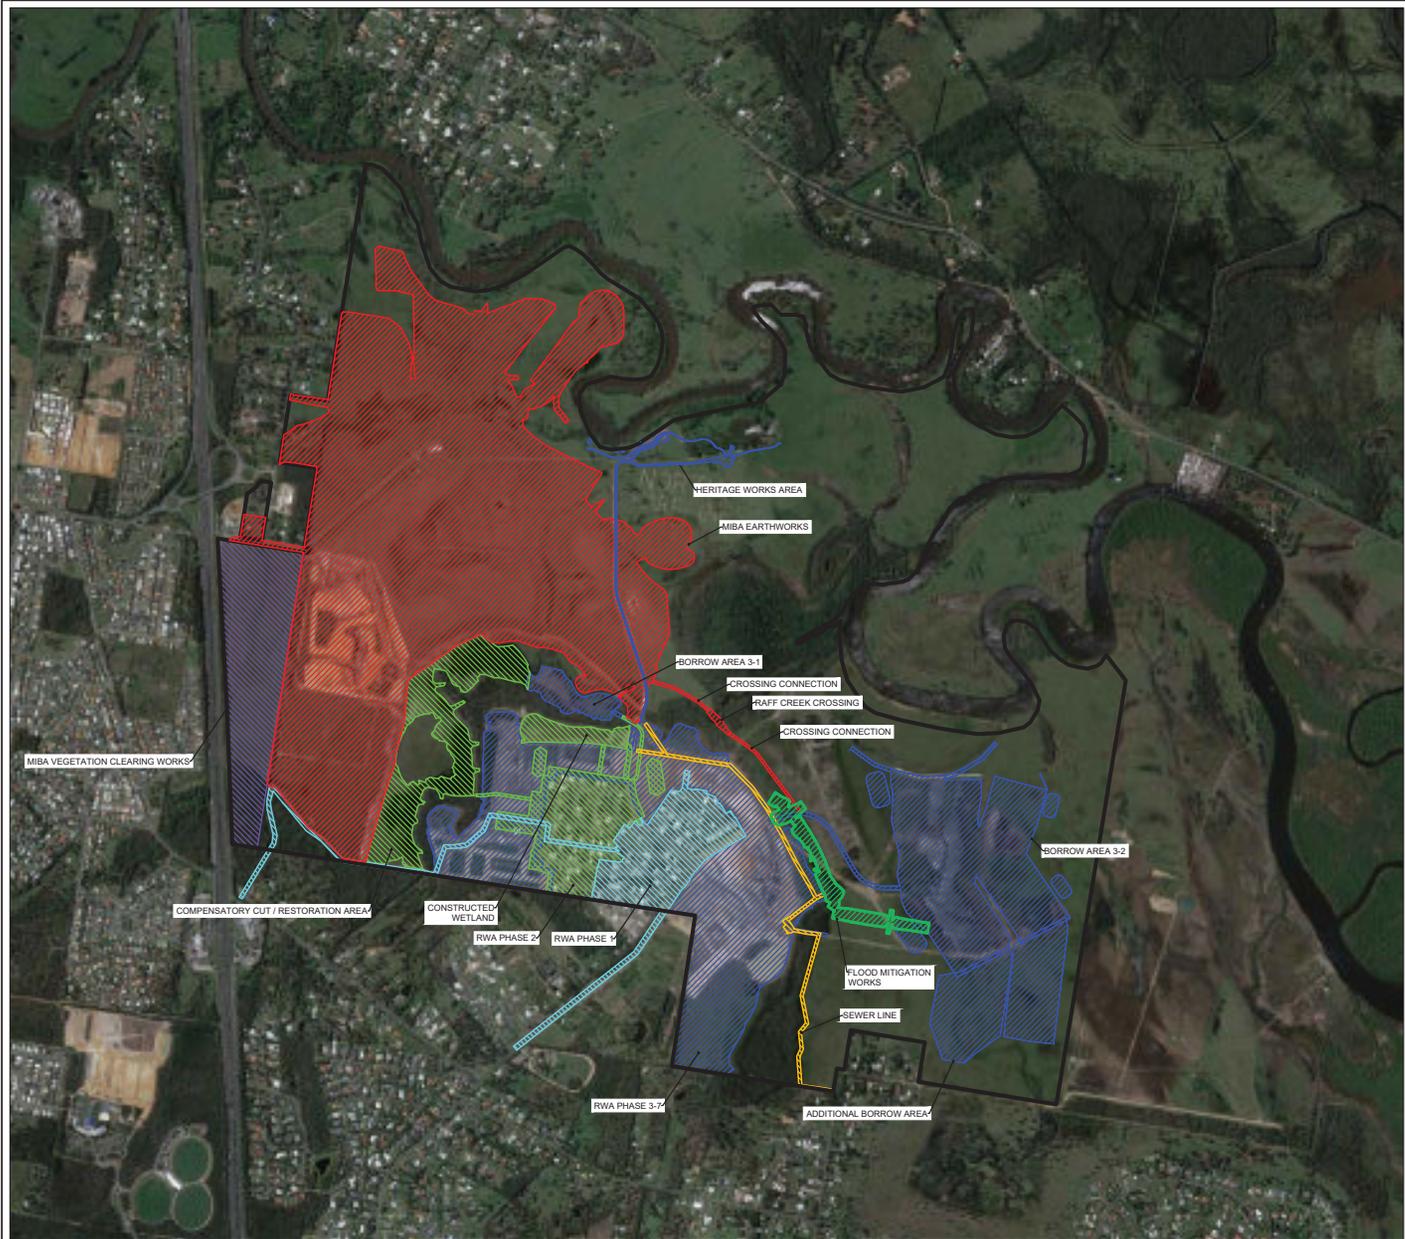
- NEBP Site Boundary
- LBEMP Sub-plan 07 Extent - Flood Mitigation Works
- LBEMP Sub-plan 06 Extent
 - MIBA (remaining areas) - Bulk Earthworks
 - Raff Creek Crossing & Connection
- LBEMP Sub-plan 05 Extent - Sewer Pump Station SPS-BGY017 (PS3) Reticulation Network
- LBEMP Sub-plan 04 Extent
 - Residential West Area - Balance (Phases 3-7)
 - Borrow Areas
 - Heritage Works
- LBEMP Sub-plan 03 Extent
 - Residential West Area - Phase 2
 - Compensatory Cut / Restoration Area
 - Constructed Wetland
- LBEMP Sub-plan 02 Extent - Residential West Area Phase 1
- LBEMP Sub-plan 01 Extent - MIBA (part of) Vegetation Clearing Works

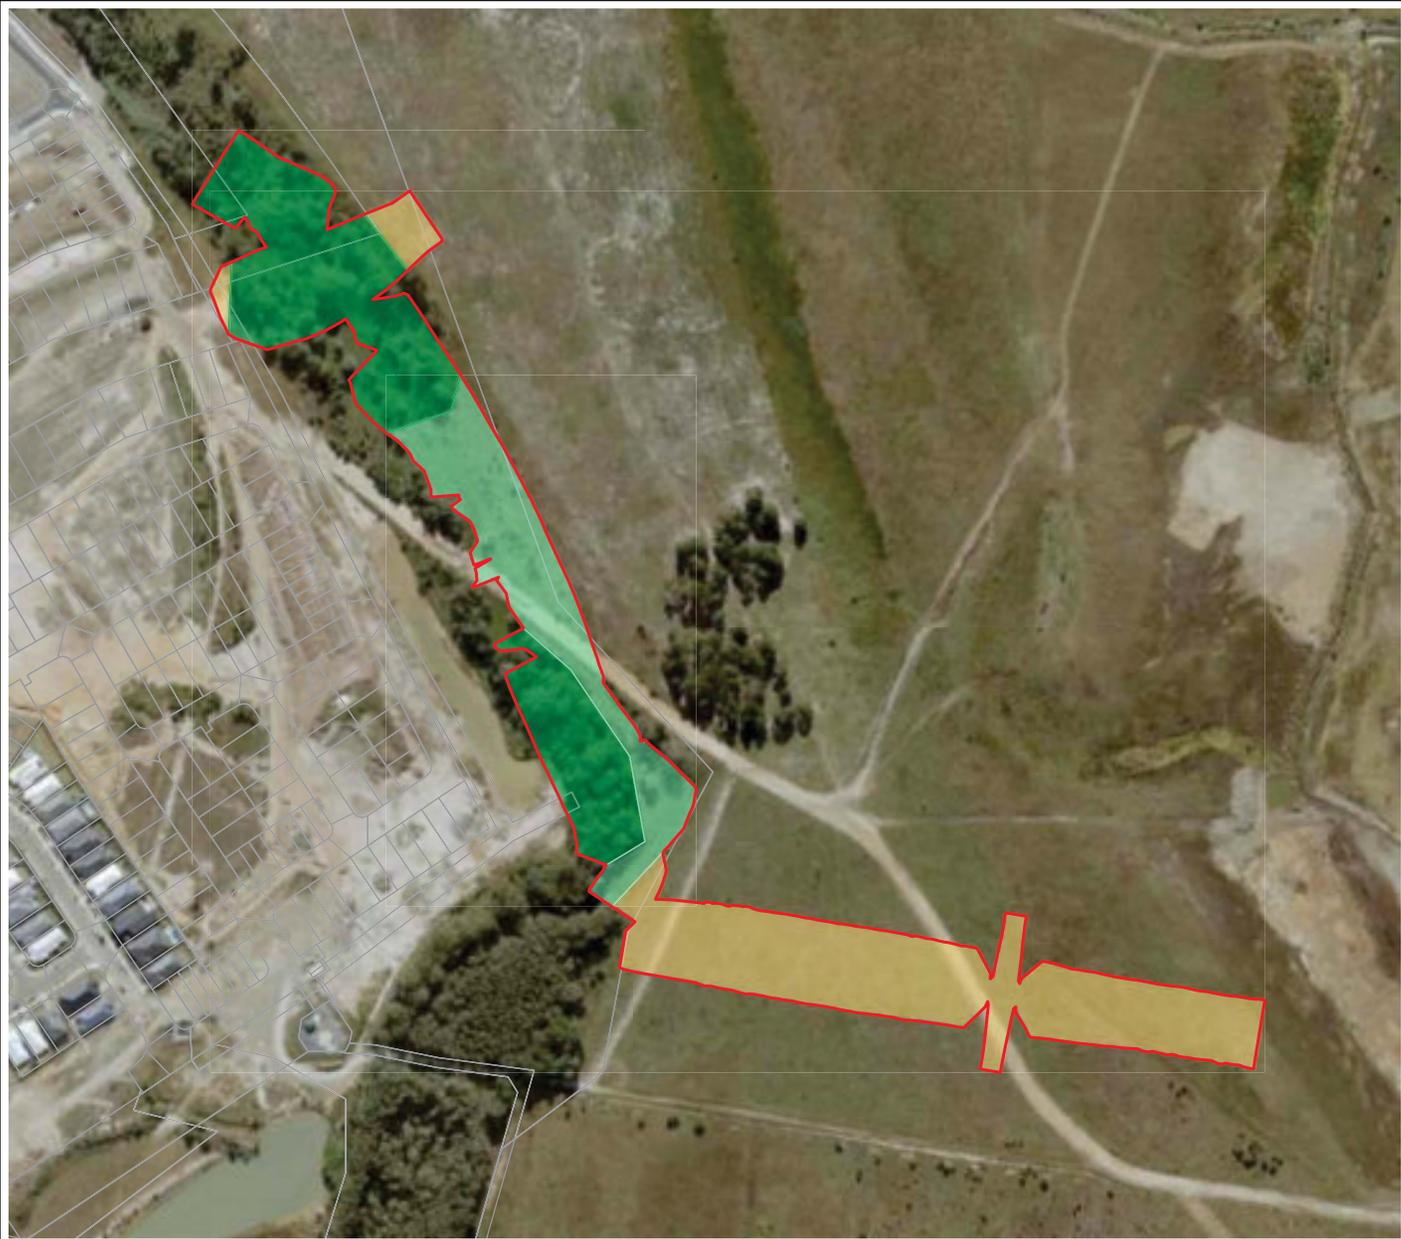
- Extent of Works
- Cadastre Boundary
- Vegetation Communities**
- Community 1: Coastal and Subcoastal Floodplain Tree Swamps - Melaleuca and Eucalypt
- Community 2: Wet Terrestrial Grassland
- Community 3: Disturbed Terrestrial Grassland

The understorey is dominated by a combination of native species and introduced plants. Native species Narrow-leaved paperbark (*Melaleuca linariifolia*), Umbrella cheese tree (*Glochidion sumatranum*), Red ash (*Alphitonia excelsa*) and Acacia spp. Introduced species include Slash pine (*Pinus elliotti**), Broadleaved pepper tree (*Schinus terebinthifolia**), Groundsel bush (*Baccharis halimifolia**), Lantana (*Lantana camara**), Devils fig (*Solanum torvum**) and Wild tobacco (*Solanum mauritianum**).

The groundcover includes some native species but was mostly exotic species. Native species include Saw sedge (*Gahnia sieberiana*), Phragmites (*Phragmites australis* - can have a weedy habit), Jointed rush (*Juncus kraussii*), Snake vine (*Stephania japonica*). Phragmites and Ghania were locally dominant in some areas of the community when associated with the drainage line. Introduced species include Fleabane (*Conyza sp.**), Blue billygoat weed

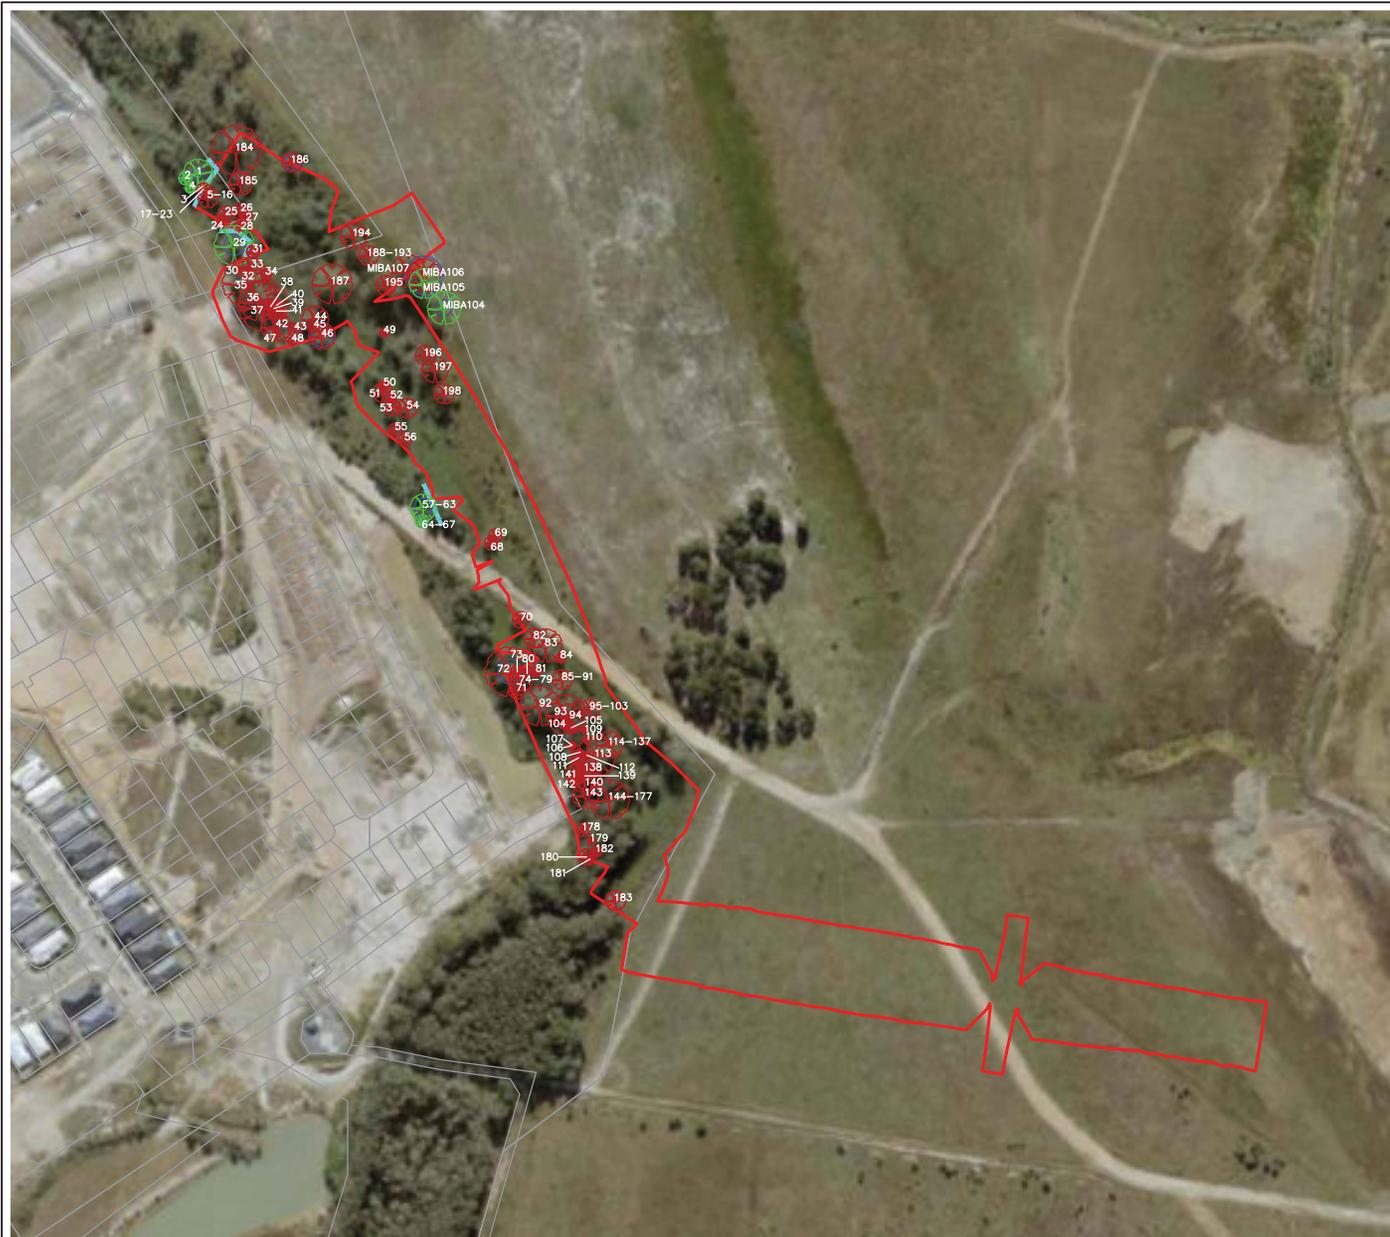
- Extent of Works
- Cadastre Boundary
- Tree Retention Plan**
- Surveyed Tree to be Retained
- Surveyed Tree to be Removed
- Tree Protection Zone
- Tree Protection Fencing

3. *Establishing the Tree Protection Zone:* The following measures will be taken to protect the tree in the long term:
 - Exclusion Fencing - Temporary fencing consisting of high visibility webbing and star pickets will be installed at the edge of works line prior to construction works (**FIGURE 4**). Temporary fencing will remain in place until all tree clearing and earthworks within or immediately adjacent to the retained vegetation have been completed.

- *Tree Protection Fences:* Tree protection fences shall be installed in the locations shown in **FIGURE 4** in accordance with the Australian Standard AS 4970-2009 (Protection of Trees on Development Sites) (**FIGURE 5**). Tree protection fences should be installed under the supervision of a qualified ecologist or arborist, prior to the tree clearing phase.

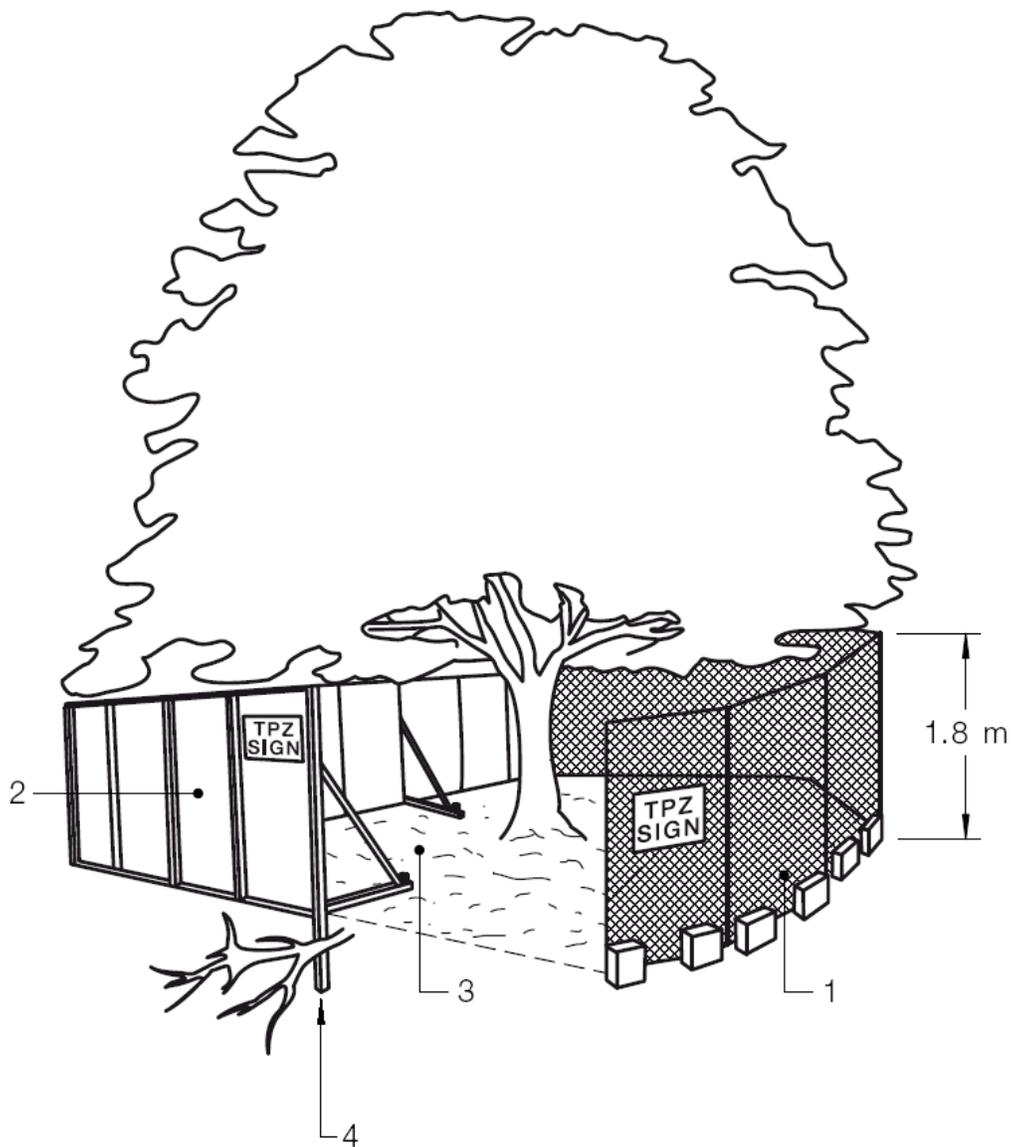
1. Chain wire mesh panels with shade cloth (if required) attached, held in place with concrete feet.
2. Alternative plywood or wooded paling fence panels. This fencing material also prevents building materials or soil entering the TPZ.
3. Mulch installation across surface or TPZ (at the discretion of the project arborist). No excavation, construction activity, grade changes, surface treatment or storage of materials of any kind is permitted within the TPZ.
4. Bracing is permissible within the TPZ. Installation of supports should avoid damaging roots.

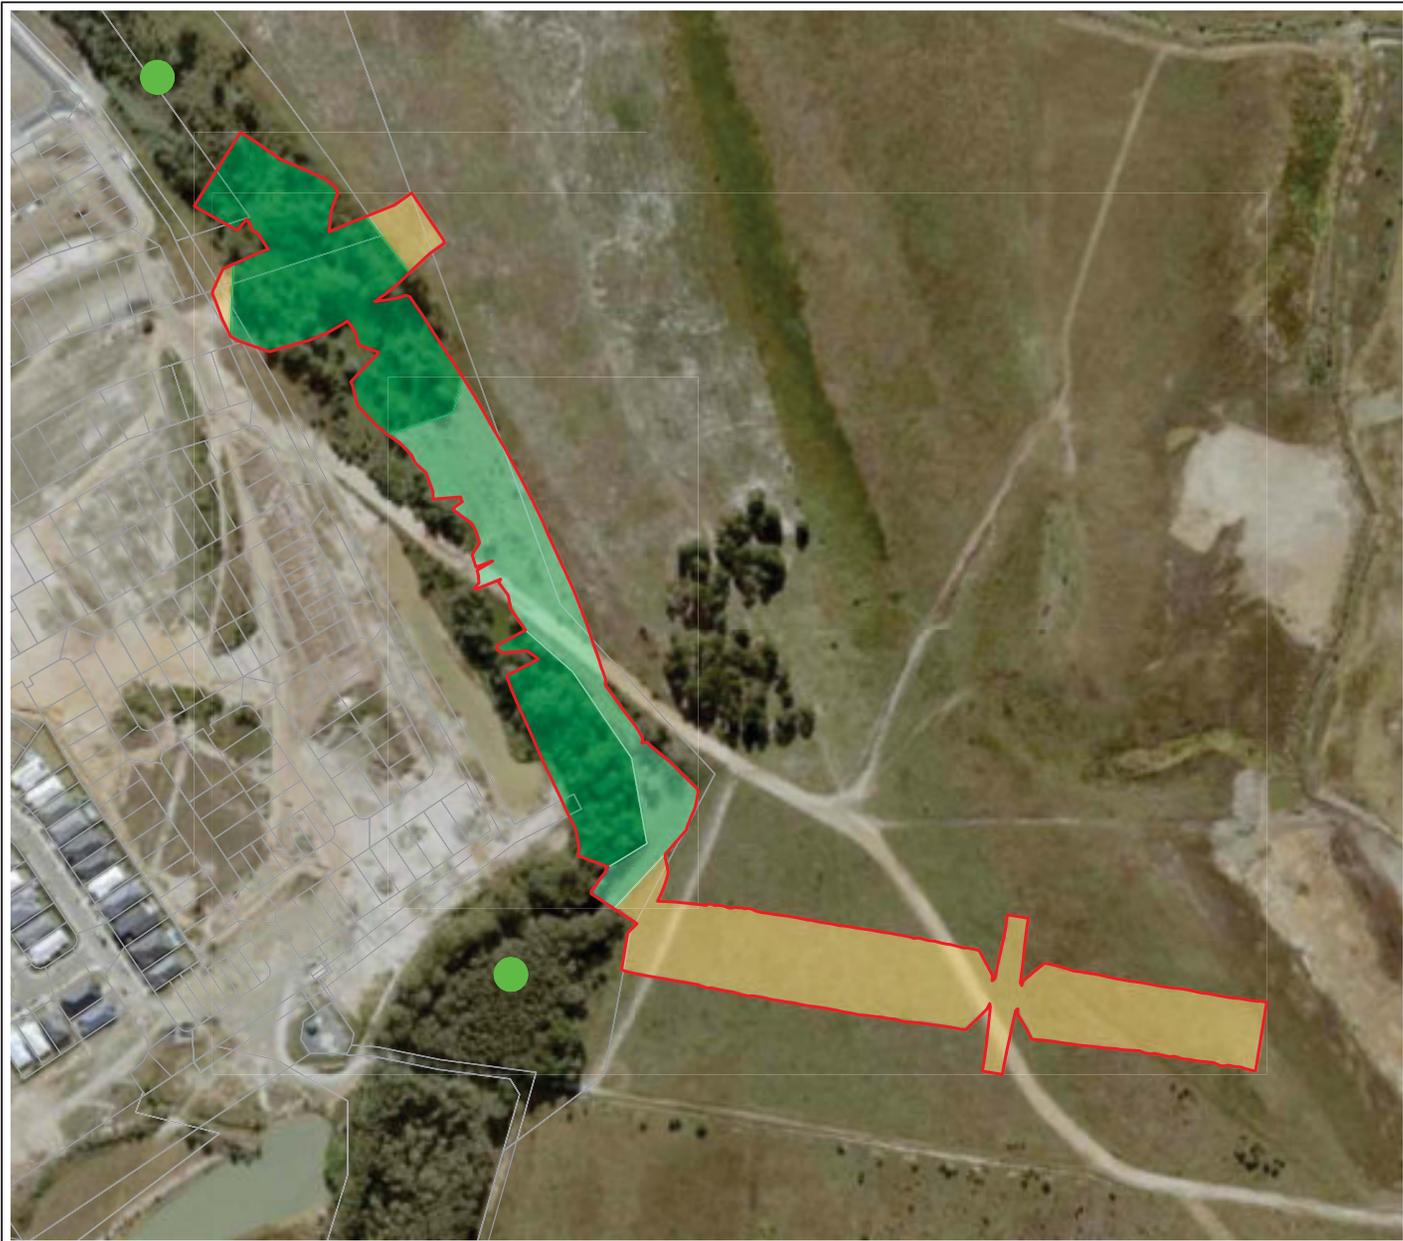
- Extent of Works
 - Cadastre Boundary
 - Indicative Weed Monitoring Location
- Vegetation Communities
- Community 1: Coastal and Subcoastal Floodplain Tree Swamps - Melaleuca and Eucalypt
 - Community 2: Wet Terrestrial Grassland
 - Community 3: Disturbed Terrestrial Grassland

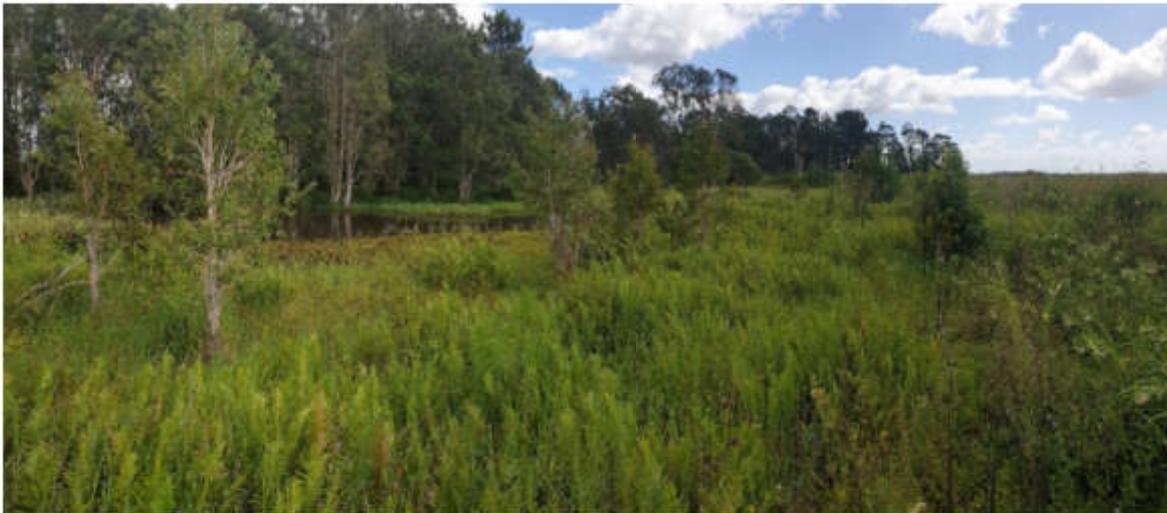
Text Figure 2: Typical site condition at the time of investigation

Existing ground cover comprises thick grasses and patches of well-established shrubs and native trees, particularly within lower sections of the drainage corridor. Existing ground surfaces within the subject site typically grade toward the drainage alignment with existing ground surface elevations ranging between RL 1 m and RL 3.5 m AHD.

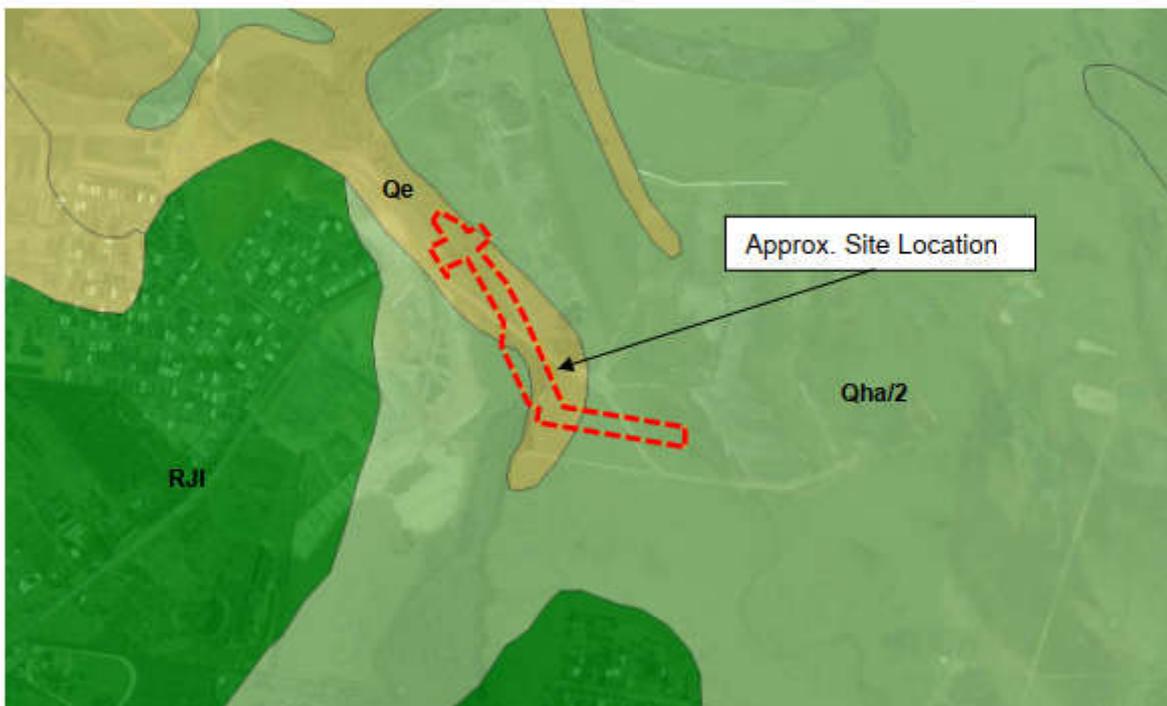
Text Figure 3: Extract from Caboolture geological map

It is inferred that these strata are underlain at depth by a basement of much older residual soils and weathered sedimentary rocks associated with the Landsborough Sandstone formation (**RJI**) which is indicated to be present to the west.

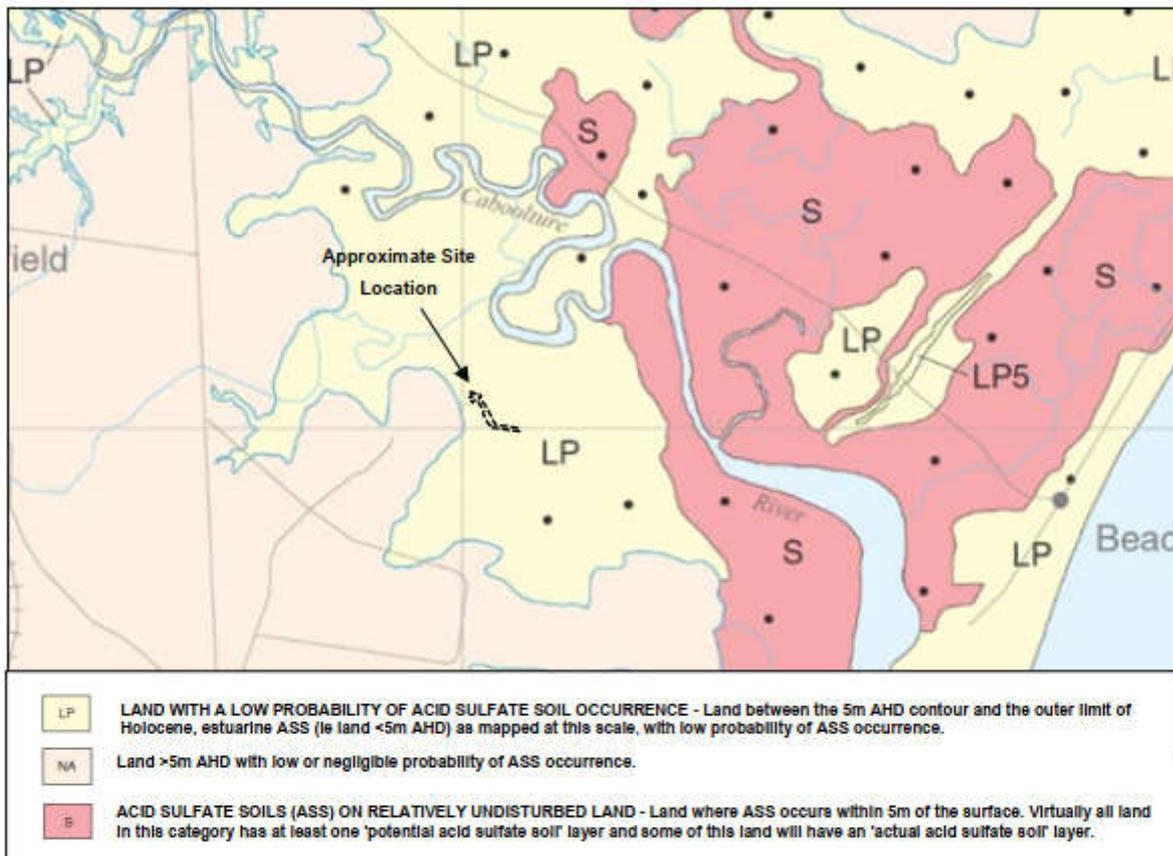
Text Figure 4: Redcliffe - Teewah Acid Sulfate Soils Map 2 (NR&M-SEA-I-A0 3261)

Mapping indicates the presence of primarily **Low Probability "LP"** land types across the subject site and surrounding land situated below RL 5 m contour. This description of the LP land type, especially across lower lying Quaternary estuarine alluvium located nearer Caboolture River, does not match with regional geological mapping discussed above in Section 5.2.1, or past site experience. Our experience is that some weak non-sulfuric acidity exists throughout the soil profile in these lower lying areas, and that some potential for AASS and PASS exists, where low strength estuarine sediments are encountered. It is noted that the established boundaries and risk probability have been established using ground contours and known geological boundaries with limited field checking. While ASS risk mapping does indicate a low probability of ASS being present across the site, some potential for ASS to exist would be likely across lower estuarine alluvial soils. The presence nor absence of ASS at a site based on broad-scale mapping alone is not

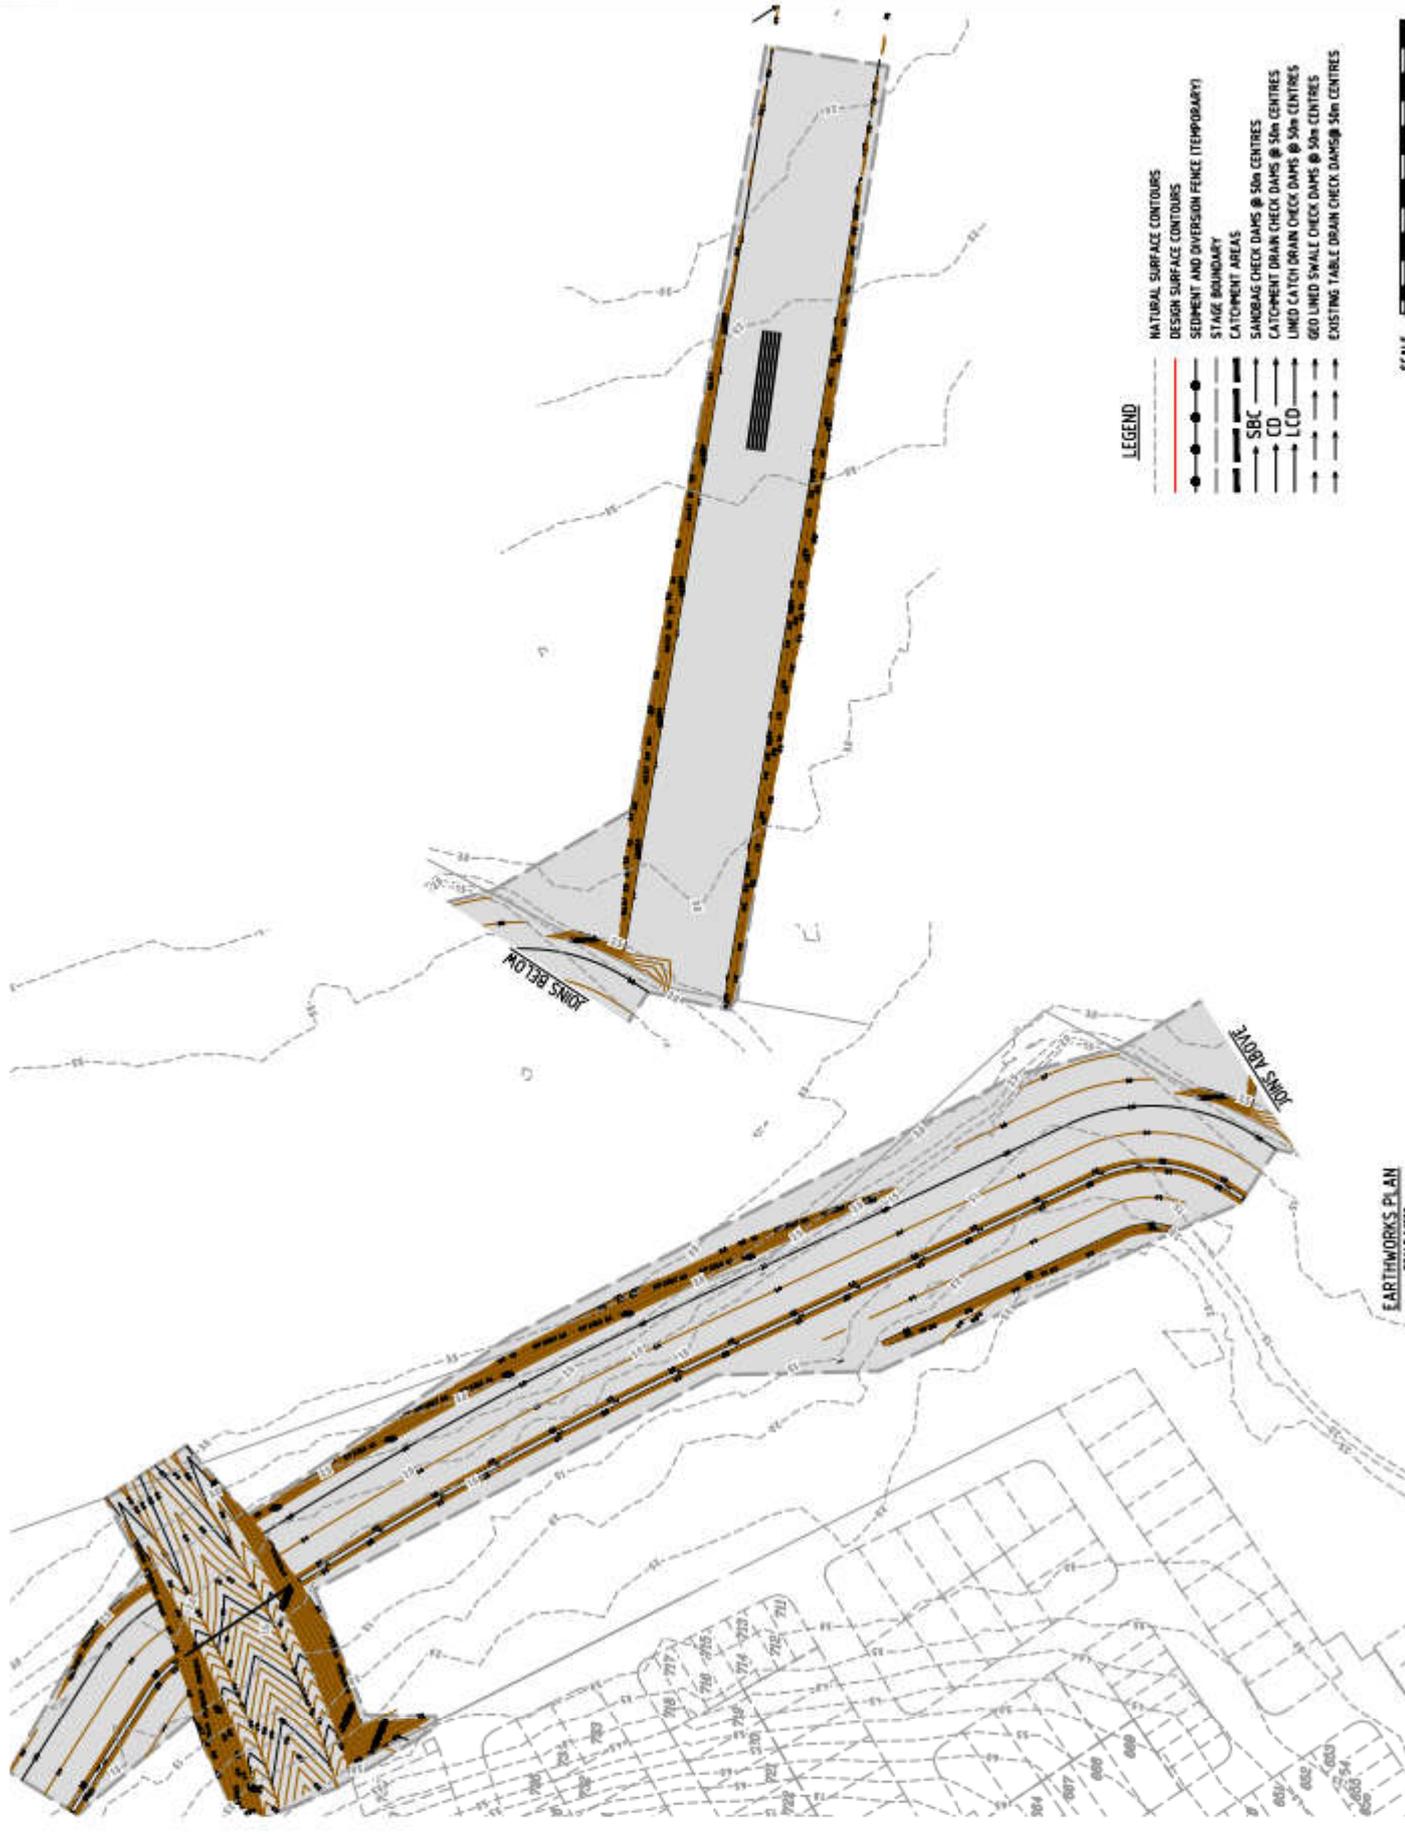
SEDIMENT AND EROSION CONTROL PLAN

- LEGEND**
- NATURAL SURFACE CONTOURS
 - DESIGN SURFACE CONTOURS
 - SEDIMENT AND DIVERSION FENCE (TEMPORARY)
 - STAGE BOUNDARY
 - CATCHMENT AREAS
 - SANDBAG CHECK DAMS @ 50m CENTRES
 - CATCHMENT DRAIN CHECK DAMS @ 50m CENTRES
 - LINED CATCH DRAIN CHECK DAMS @ 50m CENTRES
 - GEO LINED SWALE CHECK DAMS @ 50m CENTRES
 - EXISTING TABLE DRAIN CHECK DAMS @ 50m CENTRES
