Job No.: 23-186
Our Ref: 3666
Author: Dennis Alazigha

May 30, 2023

**RE: THIRD PARTY PEER REVIEW AND ASSESSMENT OF THE
SUITABILITY OF EXISTING EARTHWORKS TO
SUPPORT RESIDENTIAL CONSTRUCTION
NORTH HARBOUR PHASE 4B
BURPENGARY EAST QLD 4505**

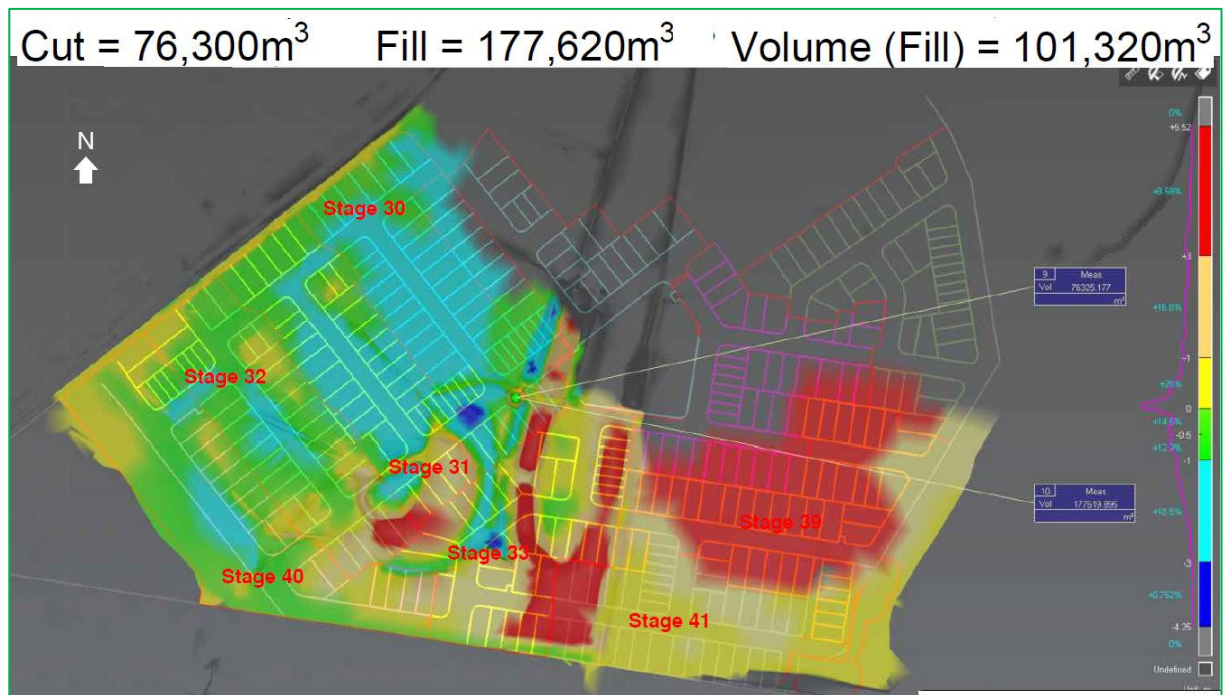
Figure 2: North Harbour Phase 4B Showing Bulk Earthwork and Layout Plan

Available information also shows that about 177,400 m³ of fill was placed throughout Phase 4B, as presented in the layout plan/'heat' map in Figure 2, indicating areas of fill up to about 2.5 m thick at some portions in Stages 31, 32, and 41.

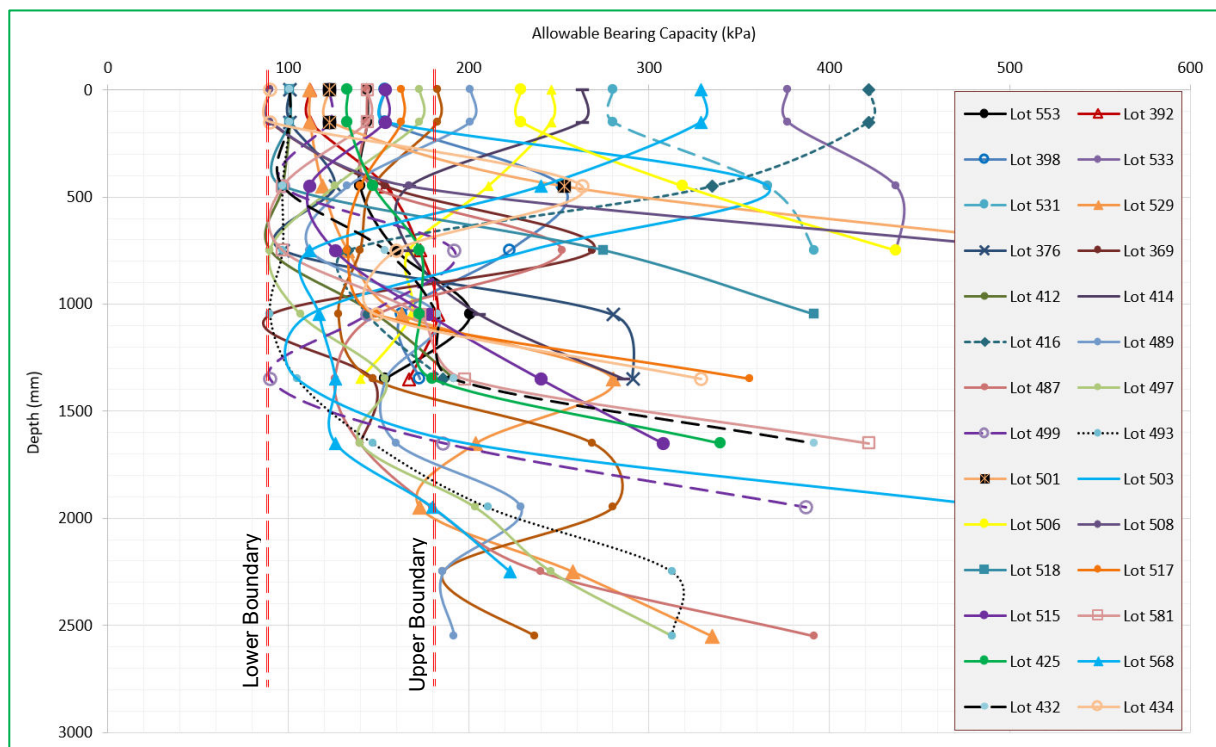
Figure 4: Bearing Capacity of Onsite Fill with Depth; Derived from DCP Data

The bearing capacity of the fill at the DCP test locations across the site with depth is presented in Figure 4.

The allowable bearing capacity for the fill underneath the topsoil to about 1.5m depth ranges from 90 to about 180kPa. This range of bearing capacity shows the fill is controlled with few localised firm layers, as shown by the lower and upper bound dotted red lines. Beyond the 1.5m depth, the bearing capacity is greater than equal to about 250kPa.

Qualtest recommends a generally conservative allowable bearing capacity of 100kPa from beneath the topsoil to about 1.5m depth. Beyond this depth, an allowable bearing pressure of 250kPa is considered suitable for the site.

The allowable bearing pressures obtained at the five test locations are within the lower and upper limits of the bearing pressures obtained from the DCP test data in Figure 4 above. Therefore, the plate load test results support our findings that the existing fill is engineered.

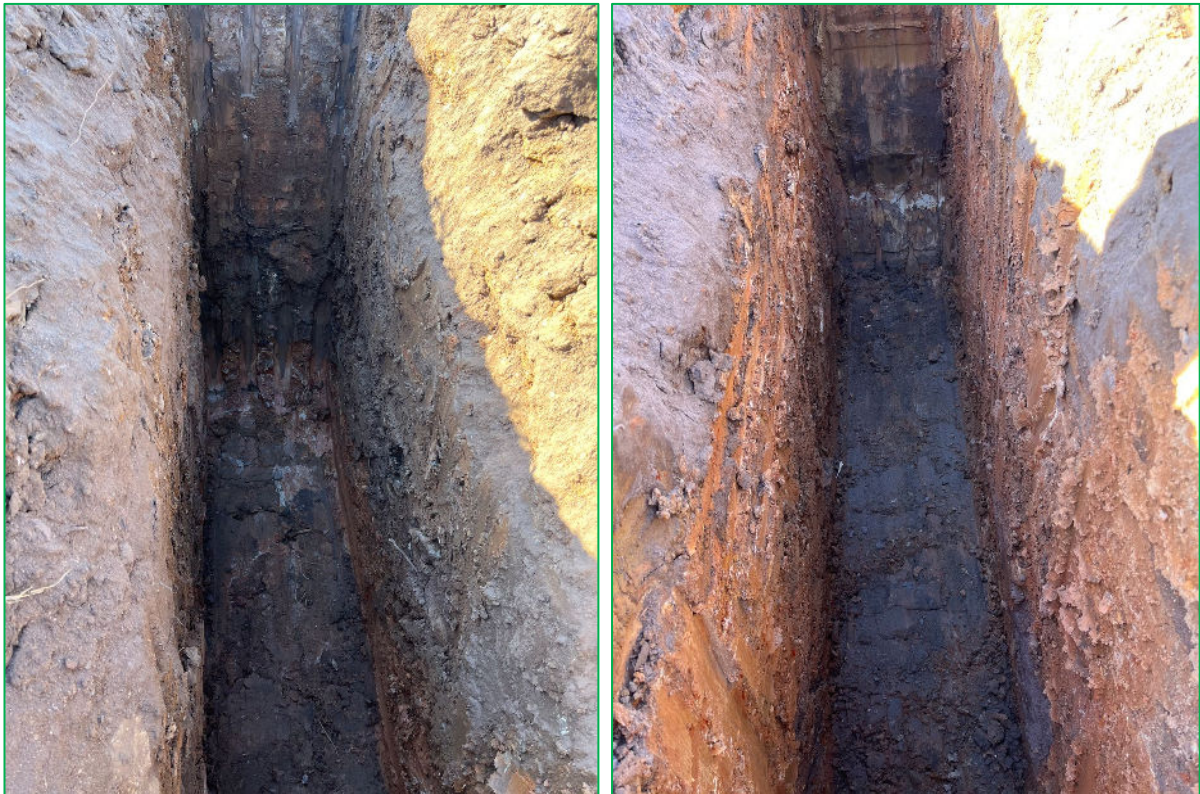
Figure 5: Typical Appearances of Test Pits Excavated Walls Across The Site

Five (5) test pits were excavated across the site for a visual-tactical assessment of the existing fill. The approximate location of the test pits is presented in Figure 3 above. All excavation walls show seamlessness, indicative of a typically controlled fill, as shown in Figure 5.

The excavations show the presence of clayey sand as topsoil, loose to very dense consistency, fine to coarse-grained sand, low plasticity clay, dark-brown, moist < PL, with root, root fibre. Underneath the topsoil is medium to high plasticity firm to very stiff sandy clay fill, fine to coarse-grained sand, with fine

to medium-grained angular gravel, dark-brown, mottled red, grey, orange, moist=PL extending to varying depth as per test location. The fill layer is underlain by natural alluvial sandy clays/clayey sands, usually very stiff, that were encountered at about 0.5m or greater depths.

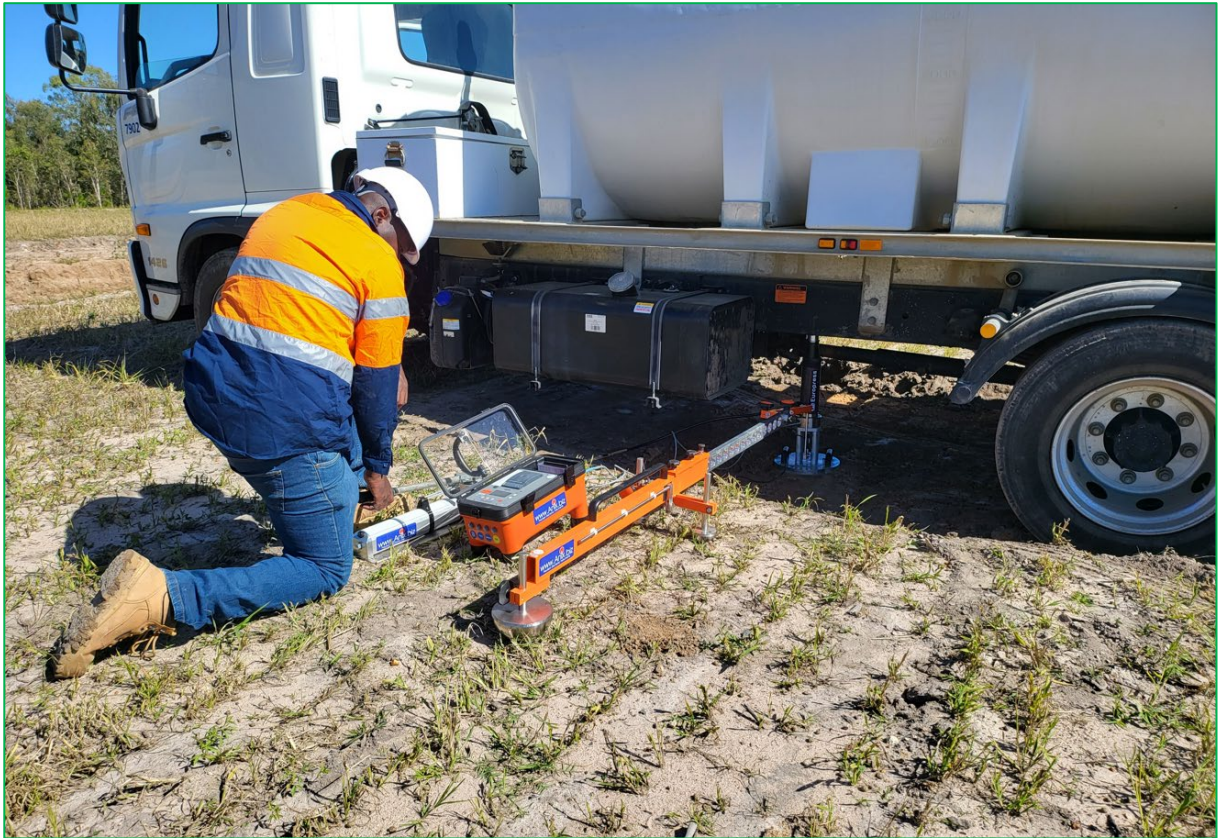
Figure 6: The Instrumented Plate Load Test Equipment Used for the Investigation

Qualtest-owned plate load test equipment, Plate Load Test AX01, was used for the investigation. The typical test setup for the electronic plate load test equipment is shown in Figure 6.

The plate load test with the electronic plate bearing tester AX01 is designed to determine load-settlement curves of soils. The obtained load-settlement curves enable the user to evaluate the deformability and load-bearing capacity of the tested materials.

The electronics of the AX01 automatically determine the needed indicators by means of the measuring results: strain modulus, E_v and modulus of subgrade reaction, k_s .
