# **LAND BASED ENVIRONMENTAL MANAGEMENT PLAN - SUB-PLAN 09**

## **Regional Park Additional Fill Areas North Harbour**

Lot 2 SP320619  
Burpengary East

A Report Prepared for  
North Harbour Holdings Pty Ltd

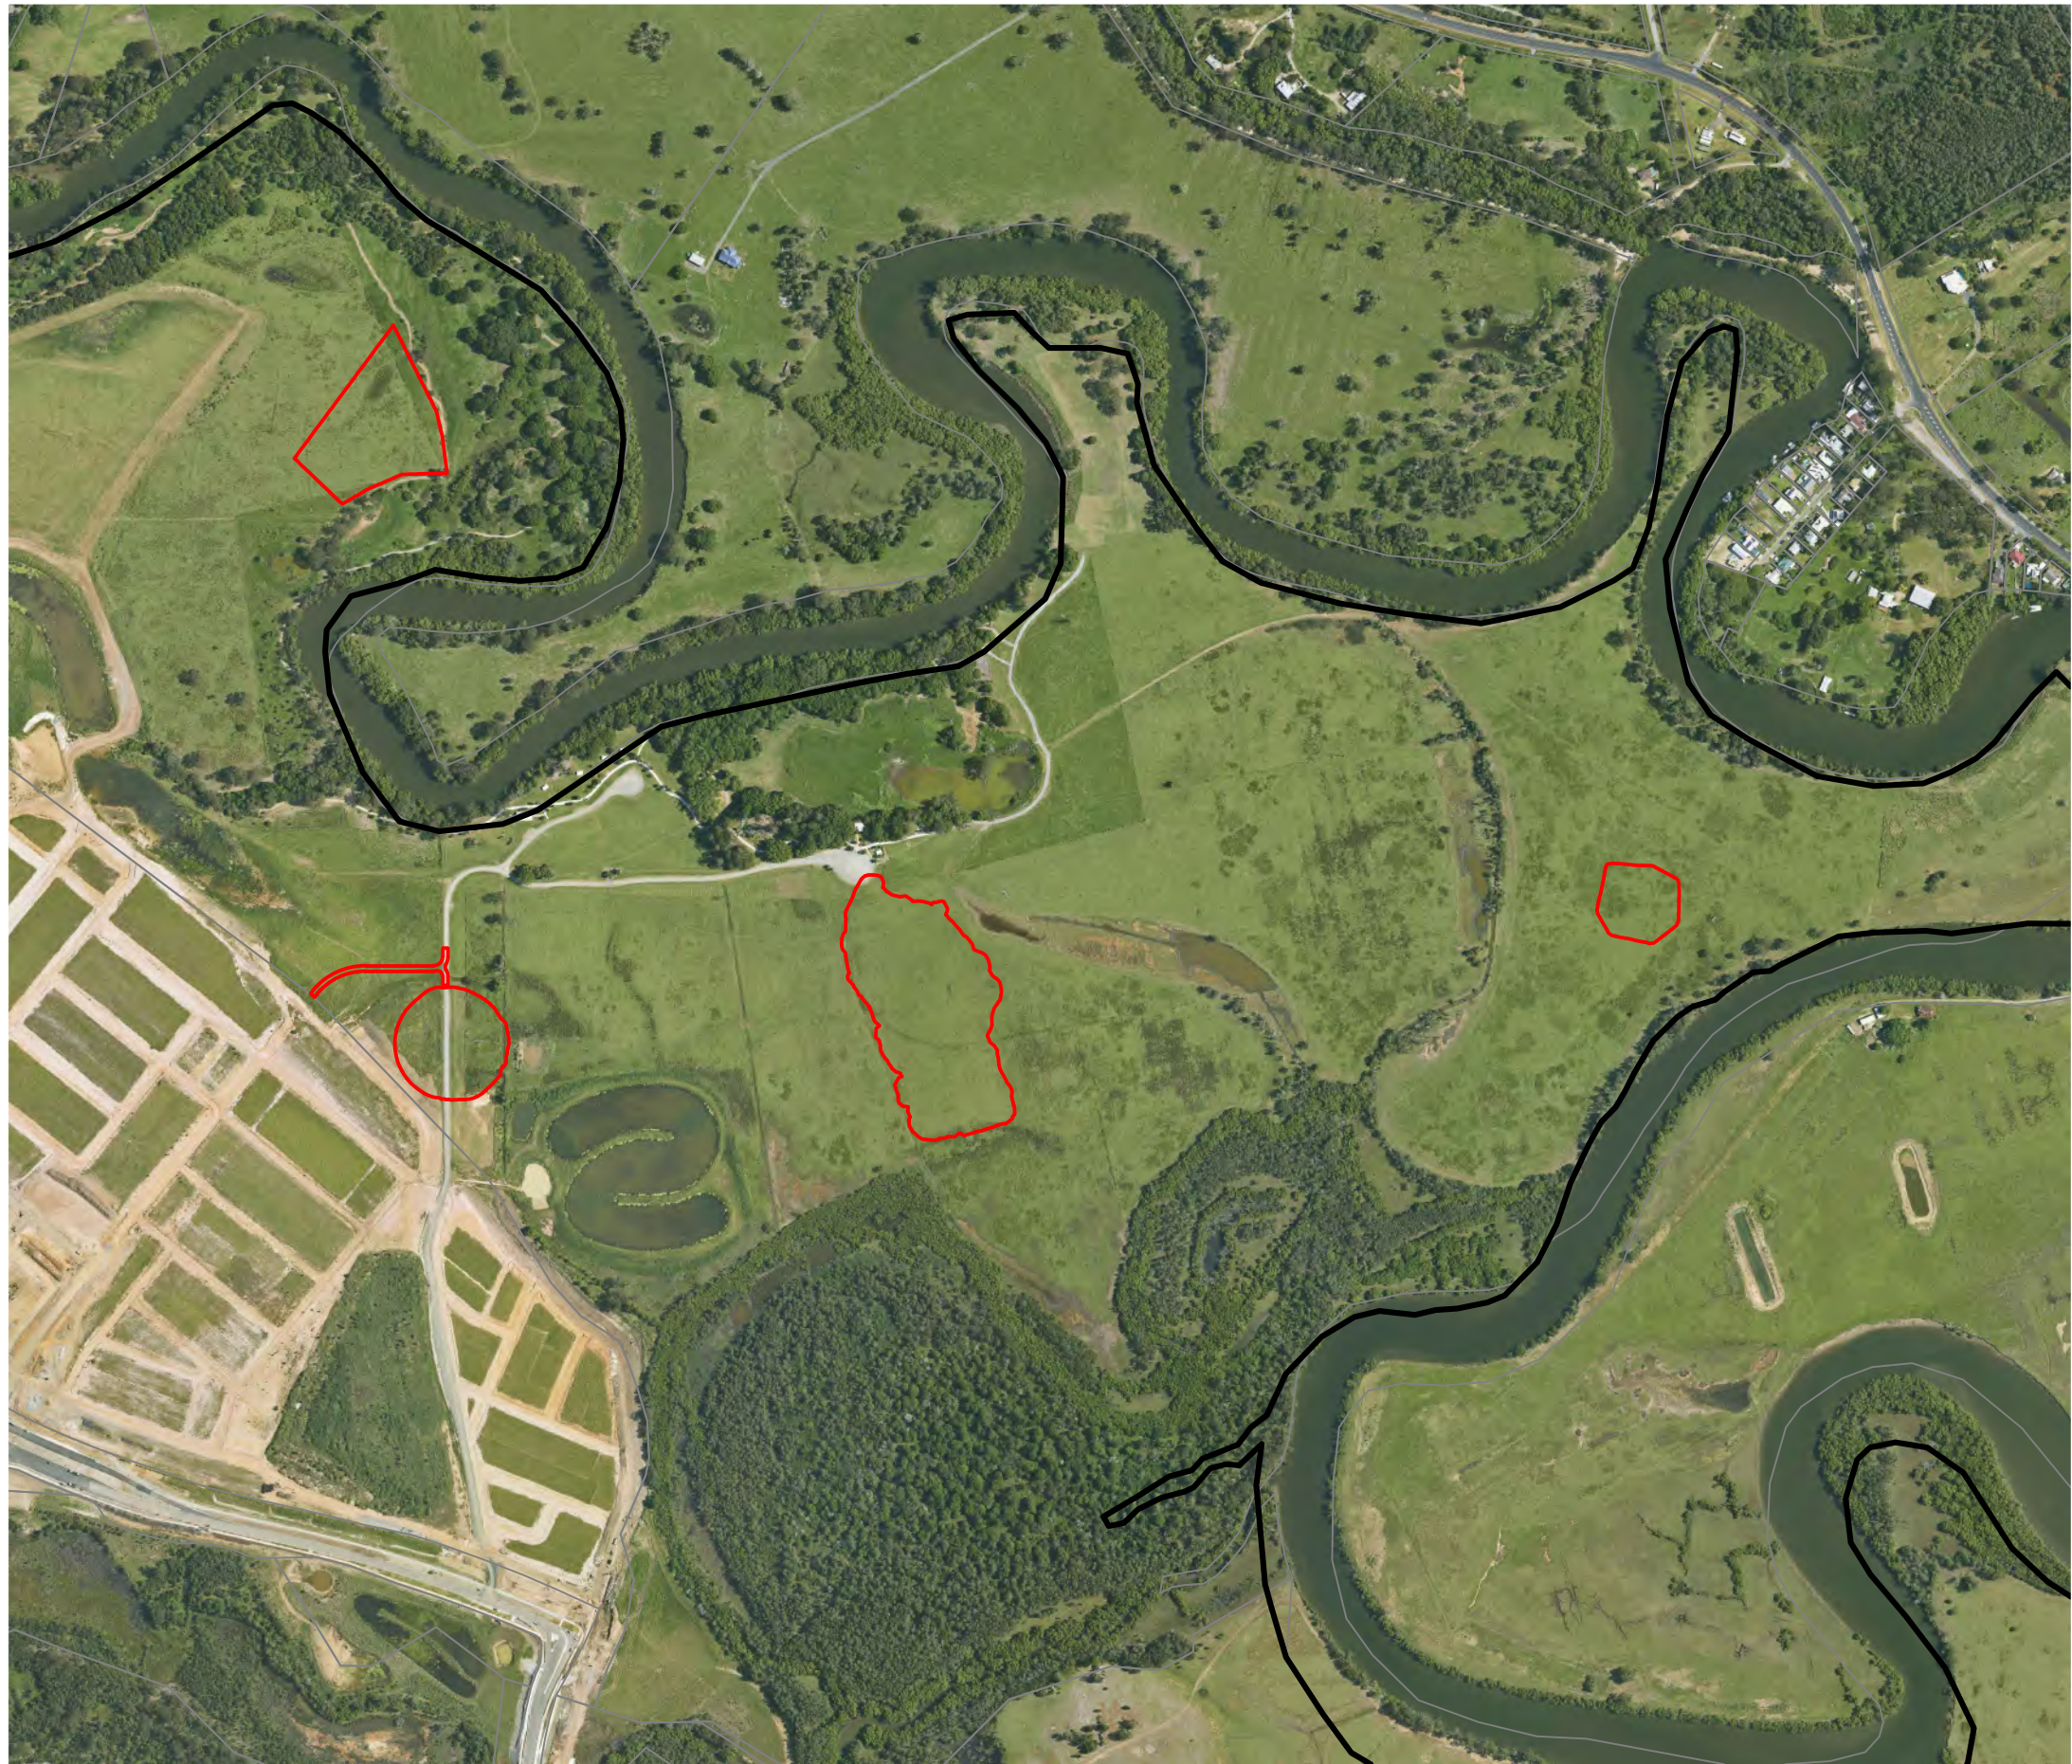
**FIGURE 2**

JWA Pty Ltd have been engaged by North Harbour Holdings Pty Ltd (formerly North East Business Park Pty Ltd) to complete a Land Based Environmental Management Plan (LBEMP) for the proposed bulk earthworks associated with the Regional Park Additional Fill Areas. The site is located land to the east of Hardwood Drive at the North Harbour development site, Burpengary East; formally described as Lot 2 on SP320619 (**FIGURE 1**). The four proposed fill areas range in size from 0.6 to 3.5 ha. An aerial photograph of the site is shown in **FIGURE 2**.

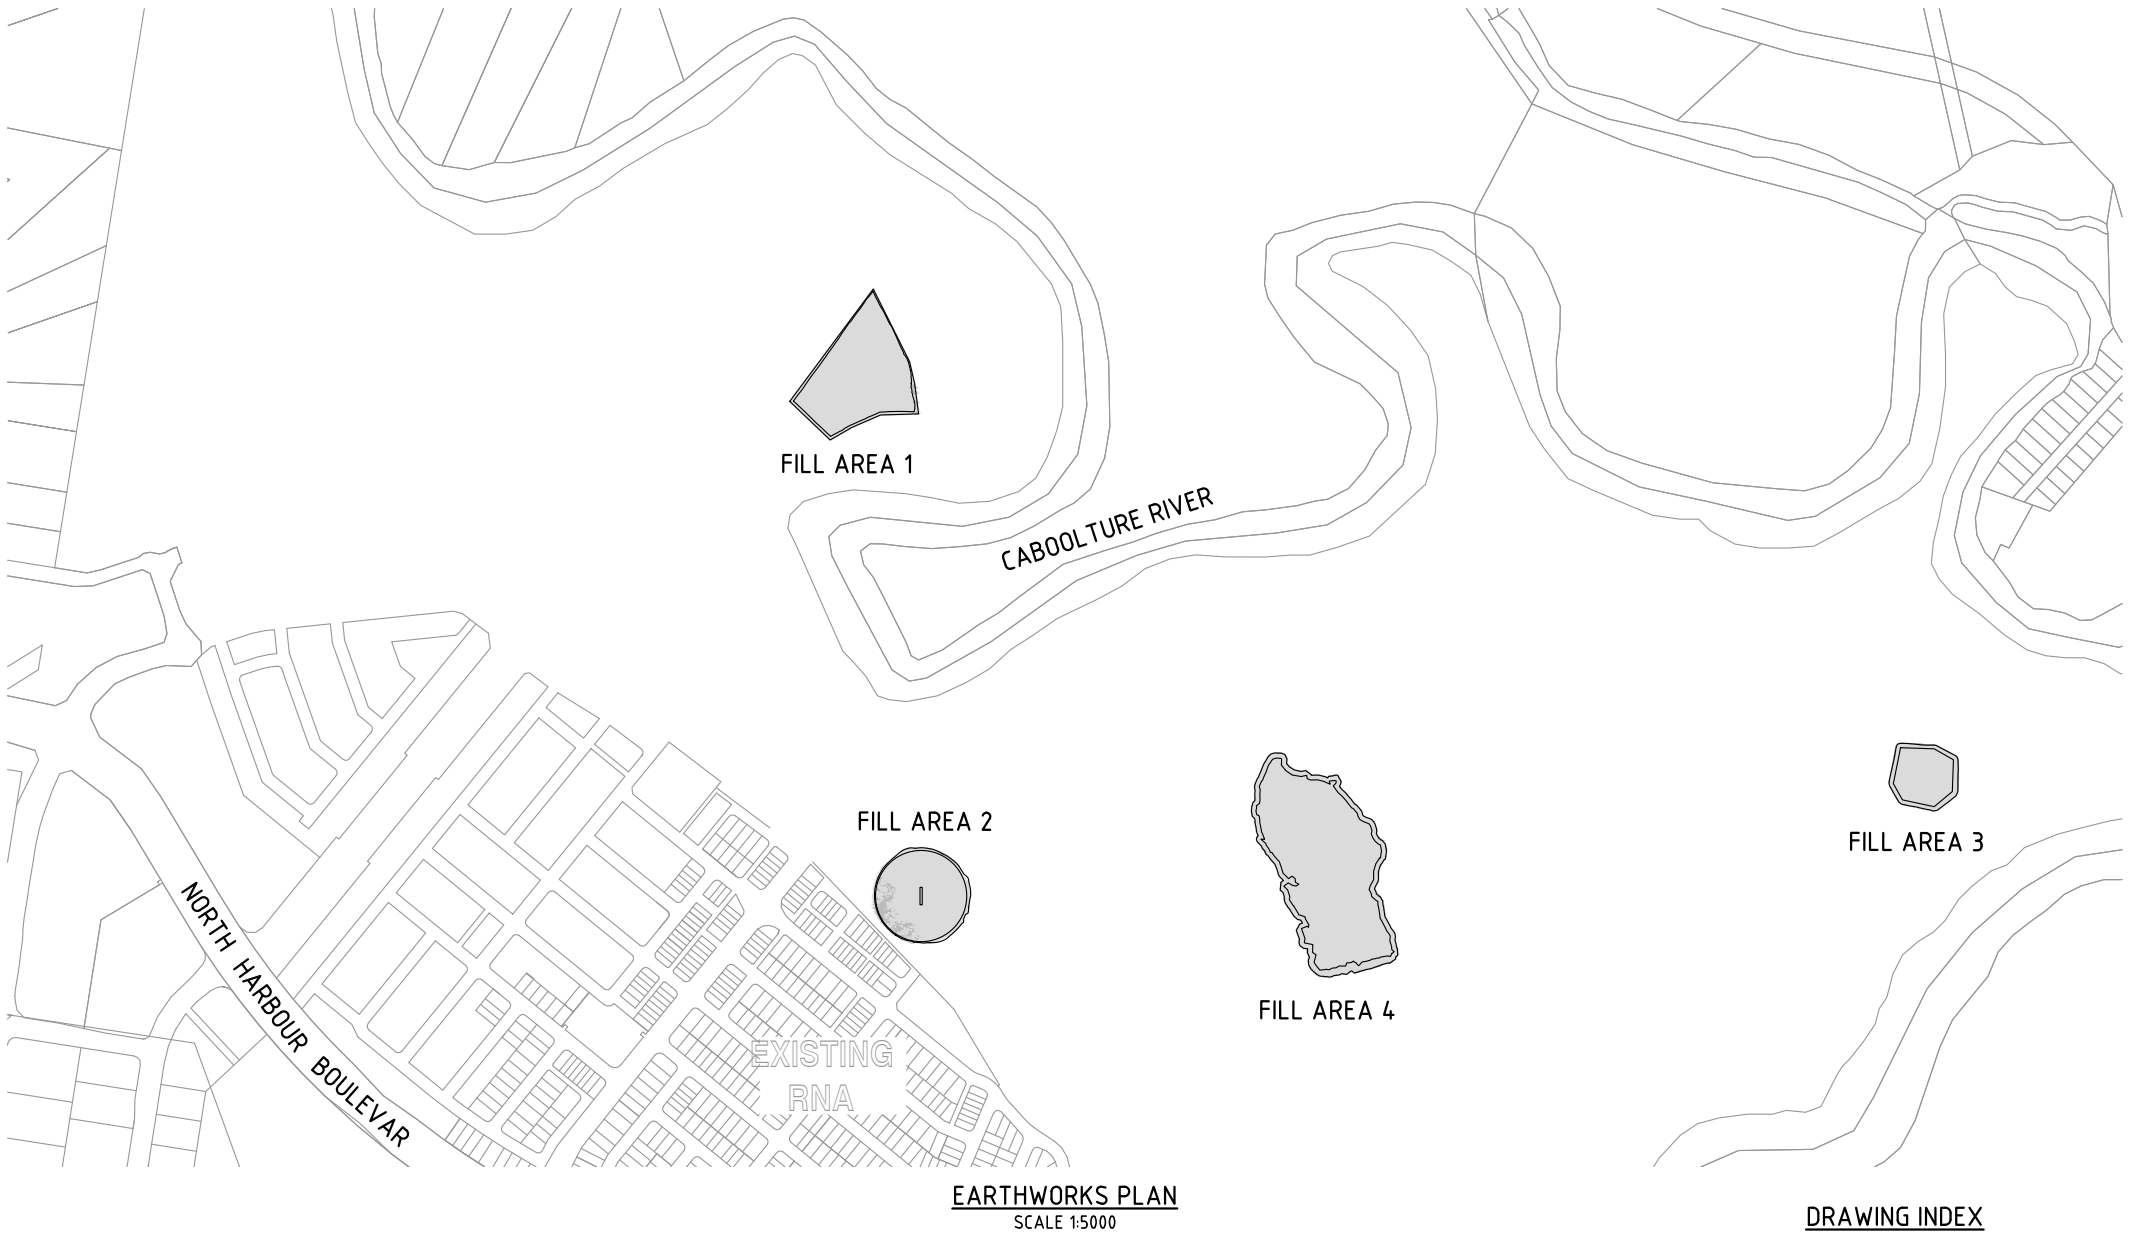
# OPEN SPACE BULK EARTHWORKS PLAN

EXTENT OF CUT

EXTENT OF FILL

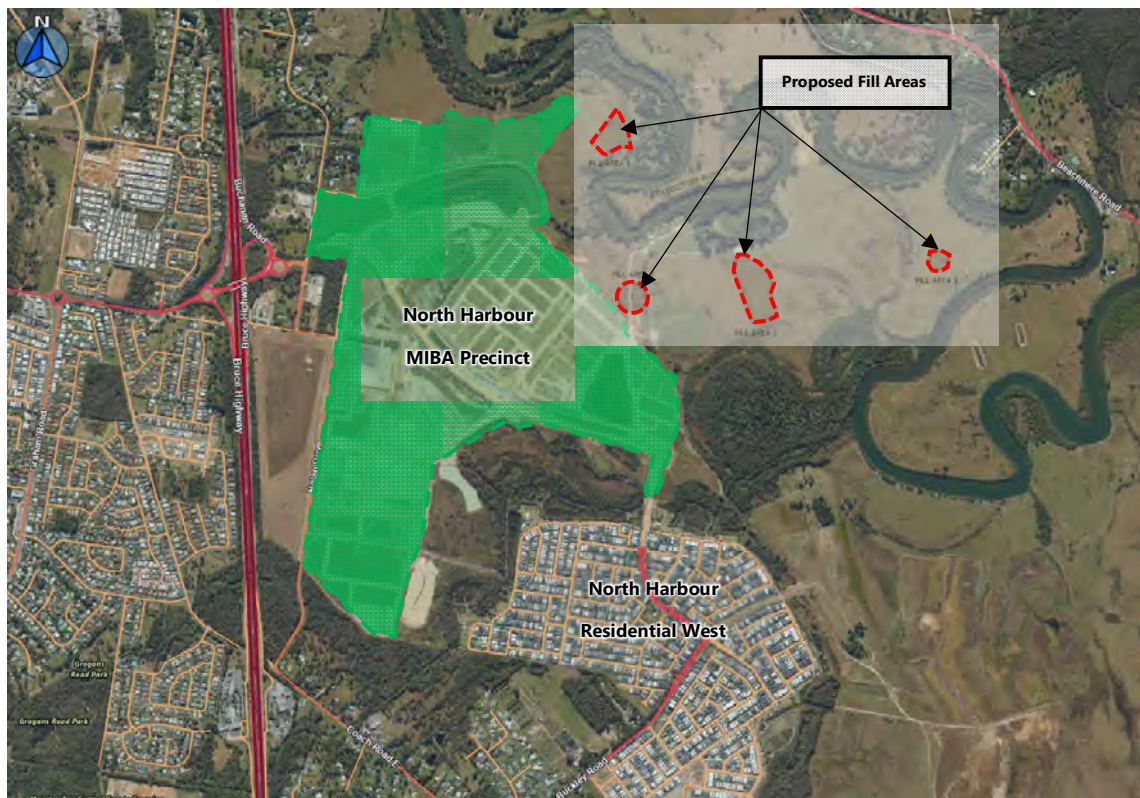
Text Figure 1: North Harbour Development Area & Subject Site

Text Figure 1 below illustrates the site location and surrounds. Text Figure 2 over page shows the general site conditions at the time of investigation.

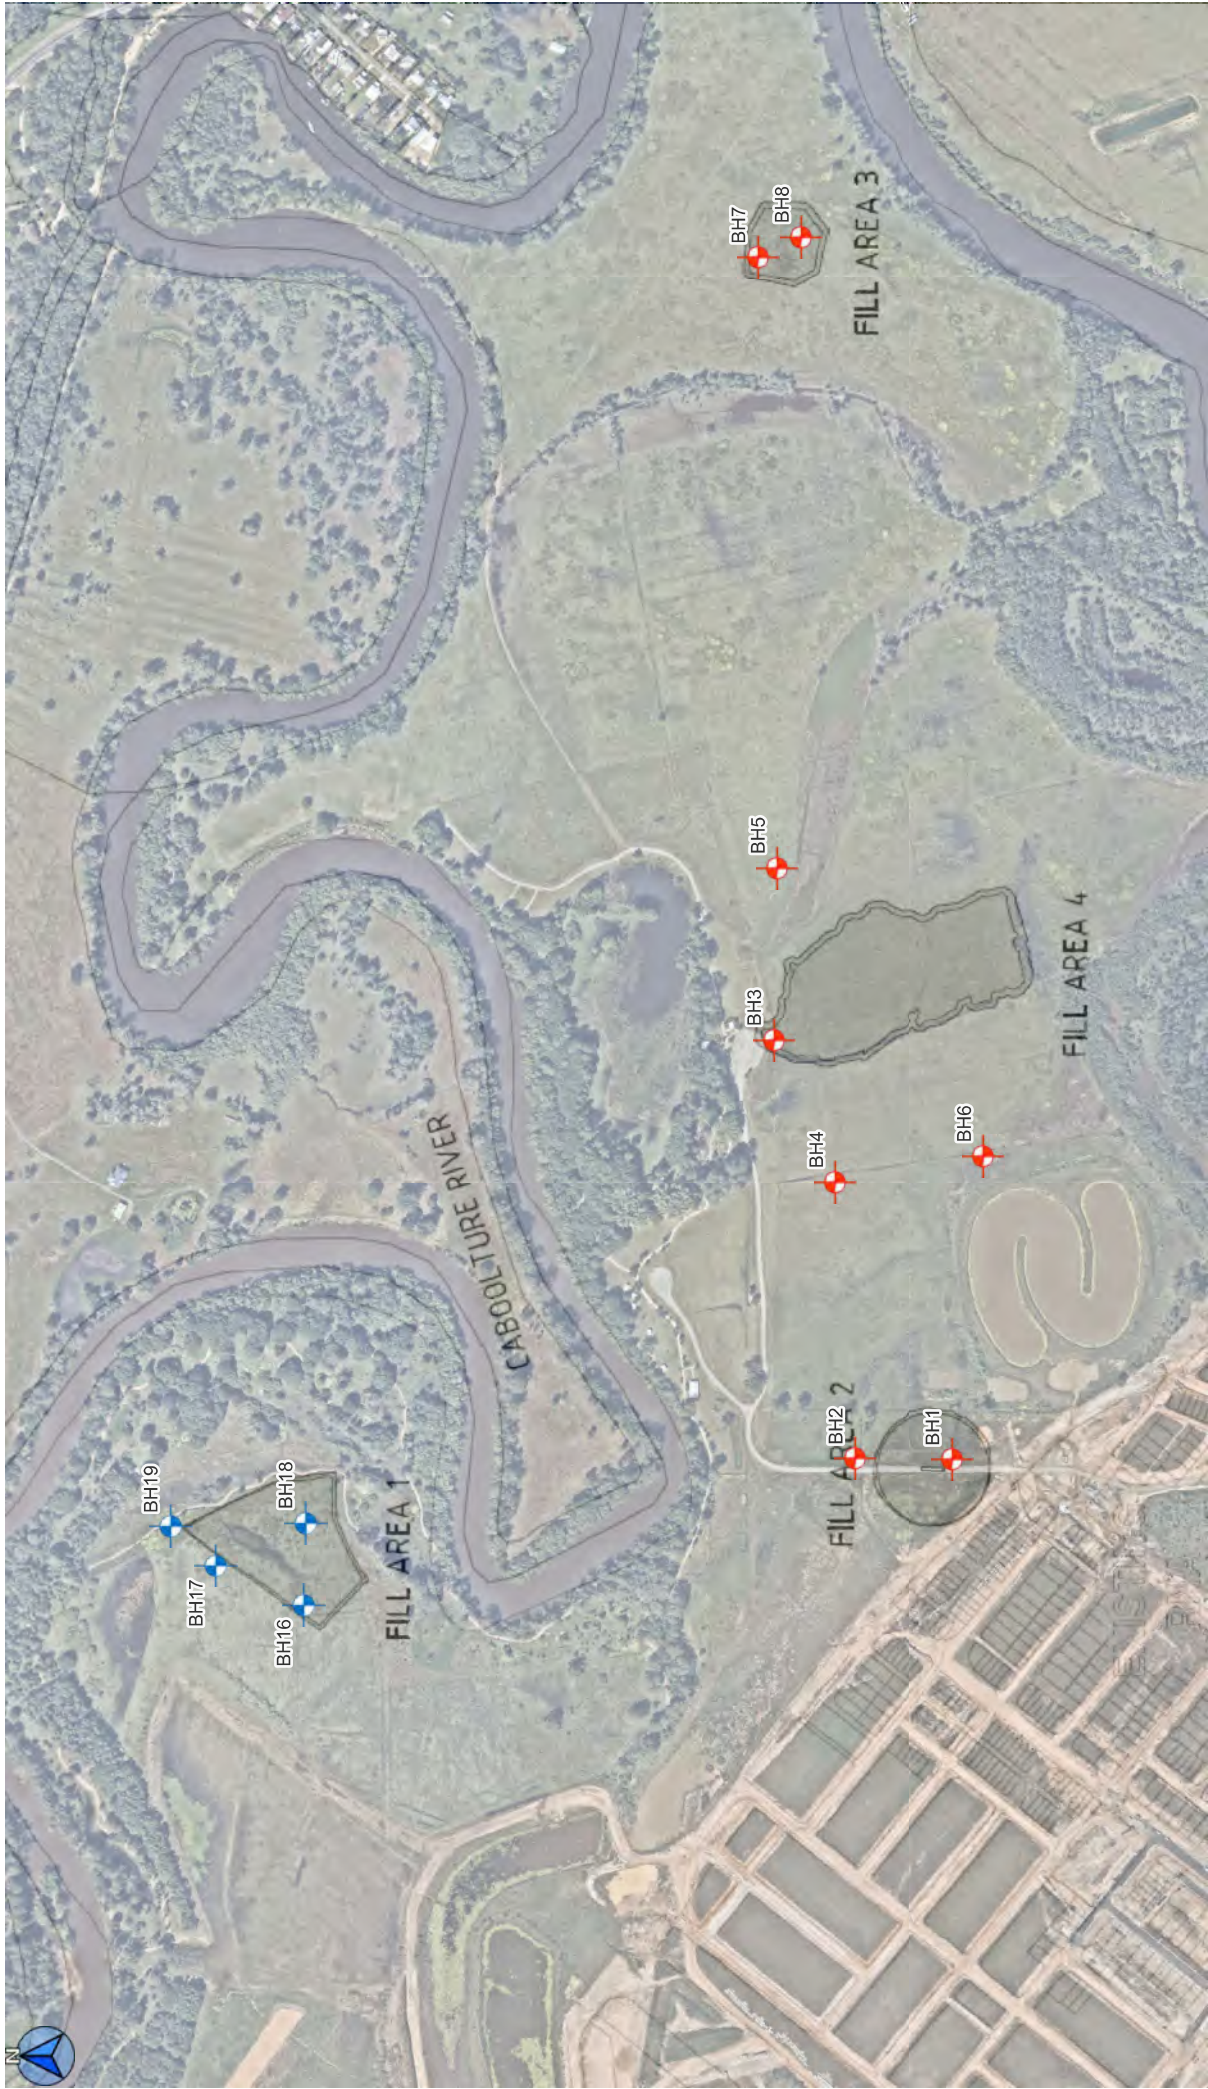
Borehole locations are illustrated in the Site Plan attached as Figure 1.
