# **LAND BASED ENVIRONMENTAL MANAGEMENT PLAN - SUB-PLAN 10**

## **North Harbour Priority Development Area Precinct 1**

Part of Lot 1 SP332514  
Burpengary East

OCTOBER 2025

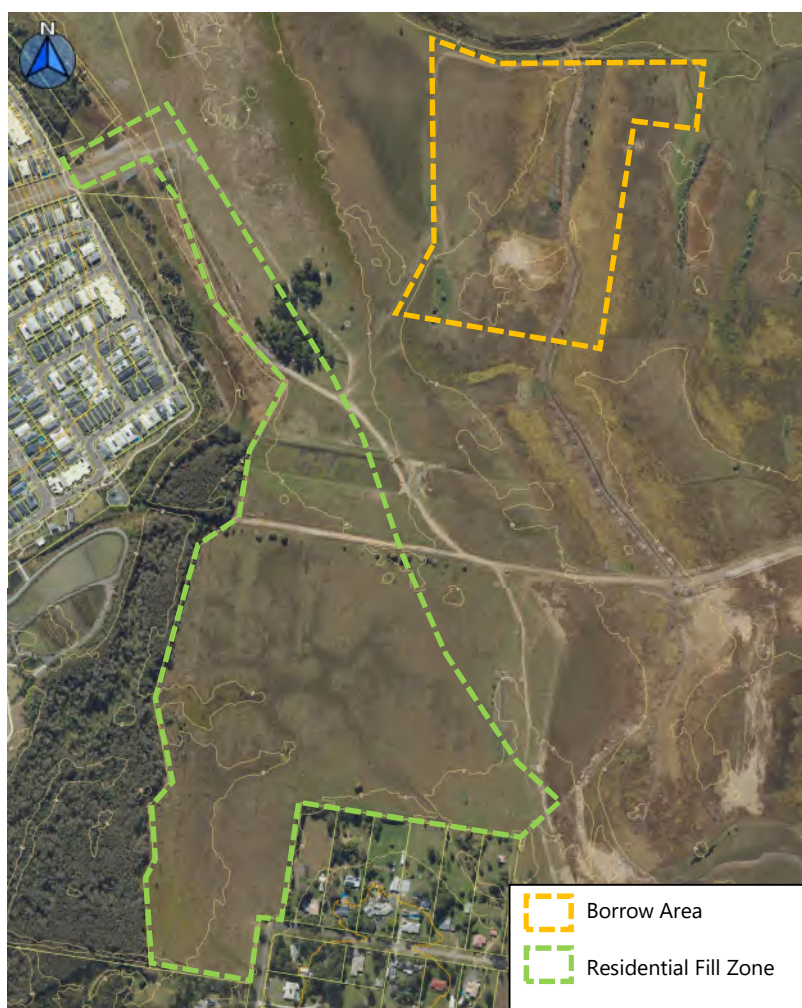
Text Figure 2: Aerial Image showing site conditions across subject works areas

Text Figure 2 below illustrates the borrow and early release residential land zones, with surface contours.
